NASA TN D-4964

DEVELOPMENT OF IMPROVED THROAT INSERTS FOR ABLATIVE ROCKET ENGINES

by Jerry M. Winter and Donald A. Peterson

*Lewis Research Center
Cleveland, Ohio*

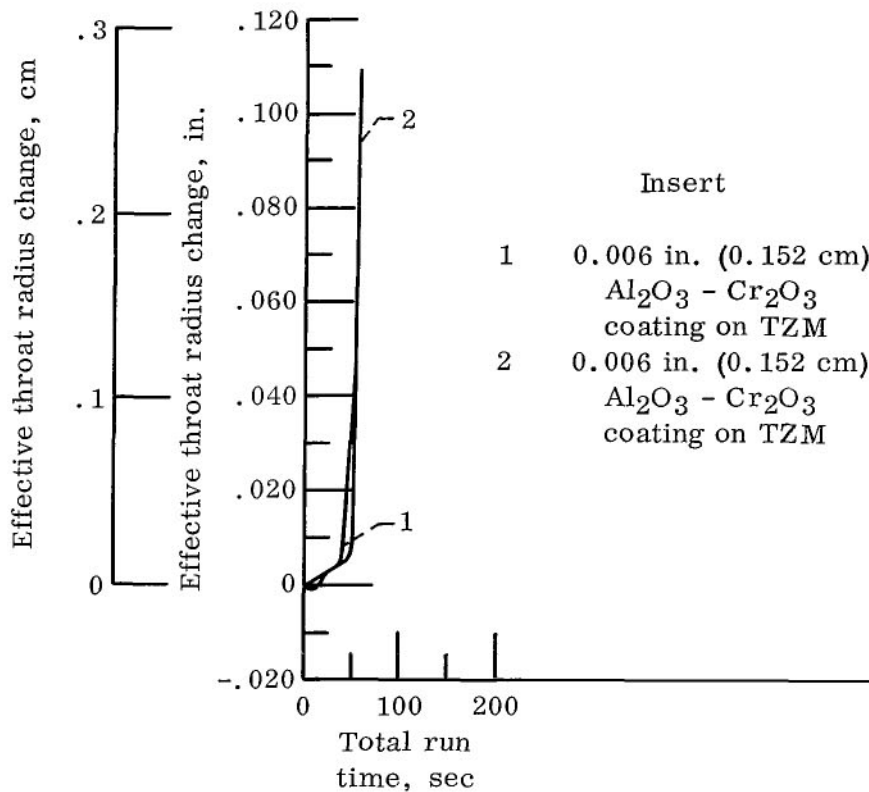
Figure 6. - Throat erosion for aluminum oxide - chromium oxide coated TZM inserts.

Inserts 1 and 2 were tested for approximately 50 seconds when a rapid increase in the throat area of each insert was noted. This rapid increase in the throat area shown

in figure 6, was caused by loss of the aluminum oxide - chromium oxide ($\text{Al}_2\text{O}_3 - \text{Cr}_2\text{O}_3$) coating followed by rapid oxidation of the unprotected TZM. Failure was primarily due to melting of the aluminum oxide layer. The coatings appeared to have adequate adhesion to the substrate. Unfortunately, the inserts were not run long enough to assess the suitability of the intermediate chromium layer at high-temperature, steady-state operation (because the aluminum oxide layer melted). Included in table VI(1) is a photograph of the fired insert number 1. The film supplement illustrates this type of failure.

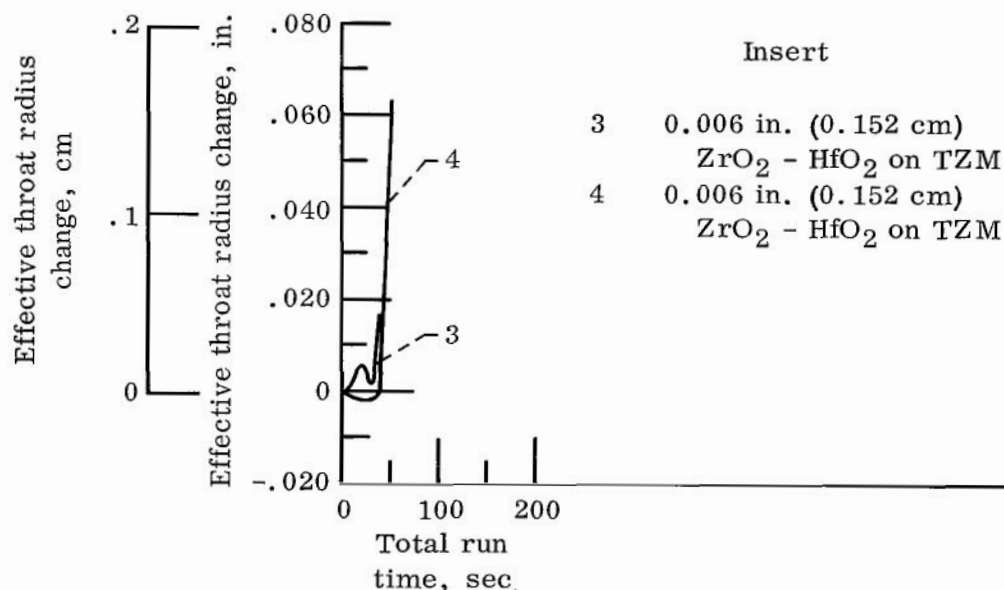
Figure 7. - Throat erosion for zirconium oxide - hafnium oxide coated TZM inserts.

Hafnium oxide - zirconium oxide on TZM. - A 0.006-inch (0.0152-cm) thick coating of hafnium oxide (HfO_2) and zirconium oxide (ZrO_2) over an intermediate layer of ZrO_2 and chromium was also applied to a TZM substrate by the plasma arc spraying and gas-pressure bonding techniques. The firing data for inserts 3 and 4 are presented in figure 7. Failure of the coating was apparently due to vaporization of the chromium in the intermediate ZrO_2 -Cr layer. This indicates that a more refractory material than chromium should be used for an intermediate layer. The film supplement also shows this failure.

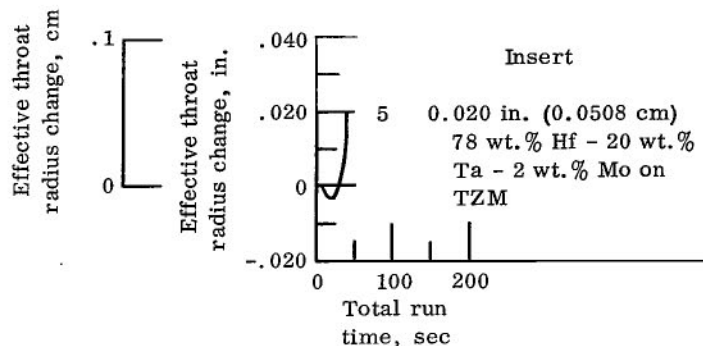
Figure 8. - Throat erosion for hafnium - tantalum - molybdenum coated TZM insert.

a plasma spray and sintering process. The firing data for insert 5 are presented in figure 8. Coating removal was caused by thermal stress, which allowed oxidation of the substrate and caused an erosion failure at about 40-seconds firing duration.

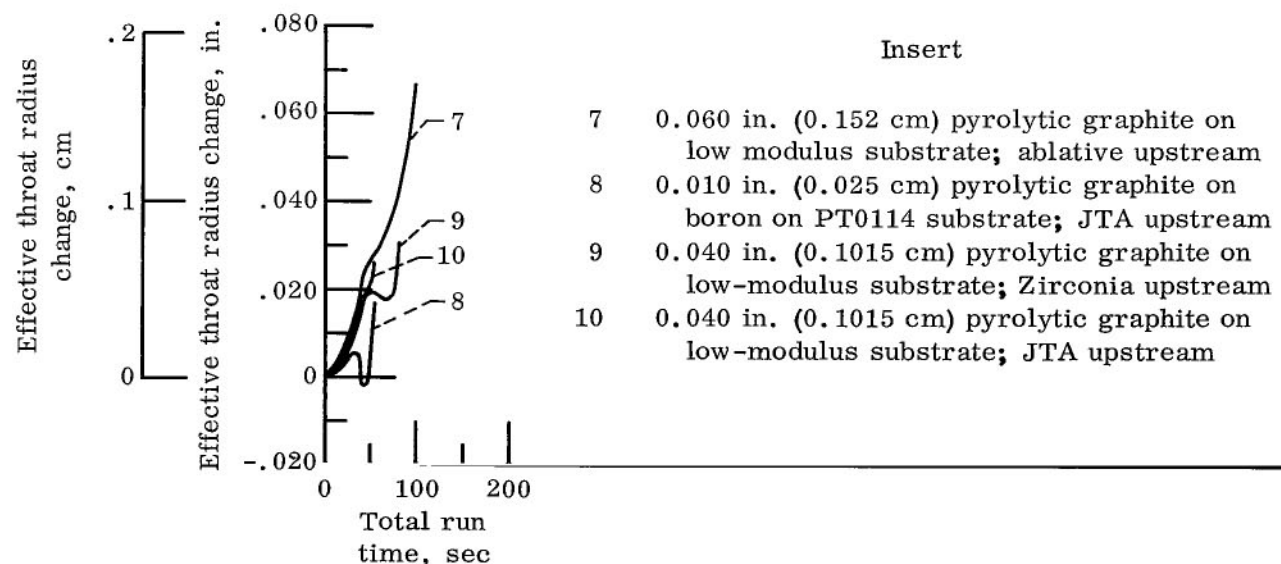
Figure 9. - Throat erosion for graphite-coated low-modulus-graphite-substrate inserts with upstream liners.

The firing results for all four inserts are presented in figure 9. Although insert 8 has only an 0.010-inch (0.0254-cm) thick coating compared with 0.060 inch (0.152 cm) for insert 7, the extended time (50 sec compared with only 20 sec) for throat erosion to

initiate in insert 8 was apparently a result of the increased oxidation resistance of the boron codeposition. Both coatings, however, lost adhesion at the leading edge as a first step to failure. For insert 7, the erosion of the upstream material (silica-phenolic) at the insert interface exposed the coating edge to the high-velocity gas stream with subsequent undercutting and attack on the substrate. When the upstream silica-phenolic material was replaced with a JTA liner for insert 8, undercutting at the insert interface did not occur. Both the coating and substrate for insert 8 cracked (see table II(8)), however, which led to oxidation of the substrate and subsequent failure of the coating. The high gas velocity experienced for insert 9 undoubtedly contributed to the premature removal of the coating in the upstream area.

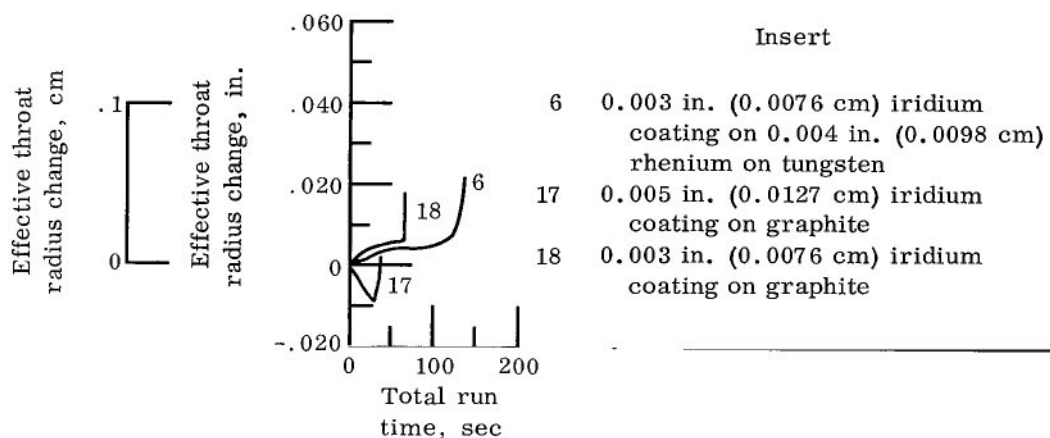
Figure 12. - Throat erosion for iridium coated substrate (graphite or tungsten) inserts.

The firing data are plotted in figure 12. The firing of both inserts was stopped when a rapid increase in the throat area (see fig. 12) was observed. The type of failure for

insert 17 is illustrated in table VI(17). Failure could be assigned to thermal stress due to a mismatch of thermal expansion or by diffusion oxidation. The negative slope recorded for insert 17 during the run could be explained by diffusion oxidation of the graphite substrate, causing carbon dioxide (CO₂) gas pressure buildup between the coating and the substrate. The relatively porous structure of the iridium, inherent with the slurry dip process, may have allowed oxygen to diffuse through the coating, react with the graphite substrate to form volatile CO₂, which caused the coating to lose support, expand outward and finally burst. This would explain the rapid area change. Because the graphite

It appears the same process of diffusion was involved in the failure of insert 18, because a thinner coating would tend to decrease the chances of failure by thermal stress. Coating loss was in progressive stages until the throat plane was affected and oxidation of the substrate increased the throat diameter. The coating was probably not strong enough (0.003-inch (0.0076-cm) thick) to remain intact after rupture. This may be seen in the film supplement.

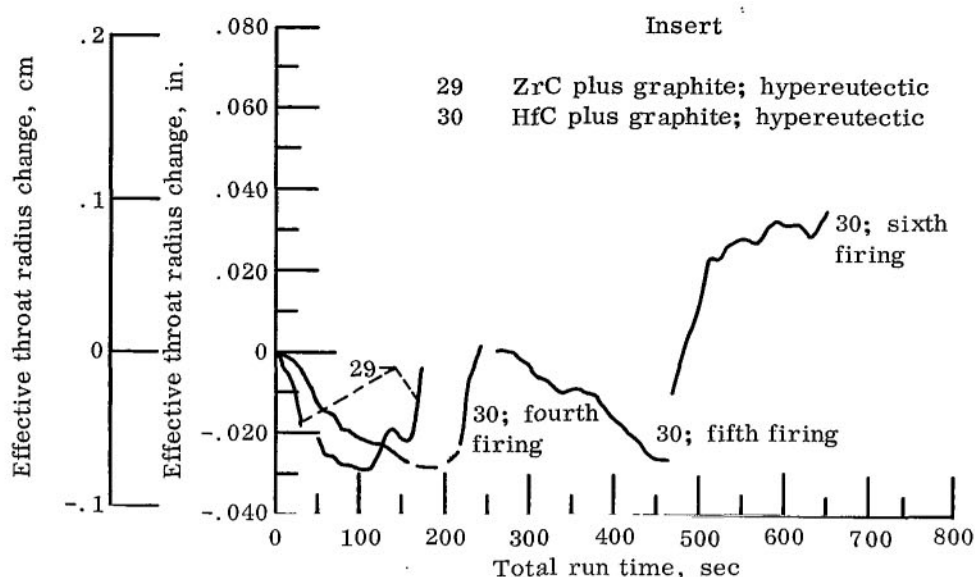
Figure 17. - Throat erosion for hypereutectic carbide inserts.

The firing data are presented in figure 17 for inserts 29 (ZrC plus graphite) and 30 (hafnium carbide (HfC) plus graphite). The first run of 25 seconds for insert 29 (ZrC plus graphite) was aborted because of a gas leak in the combustion chamber. The formation of an oxide layer reduced the measured throat radius approximately 0.025 inch (0.0635 cm). A second run was made for about 153 seconds at which time small pieces of the oxide layer came off at the throat. Excessive erosion at the upstream interface between the insert and the ablative material caused gas to flow around the outside diameter of the insert resulting in test termination (rapid area increase is shown in fig. 17). The final appearance of this insert (table VI(29)), however, indicates that the material has promise. No cracking or rapid removal of the oxidation products was experienced.

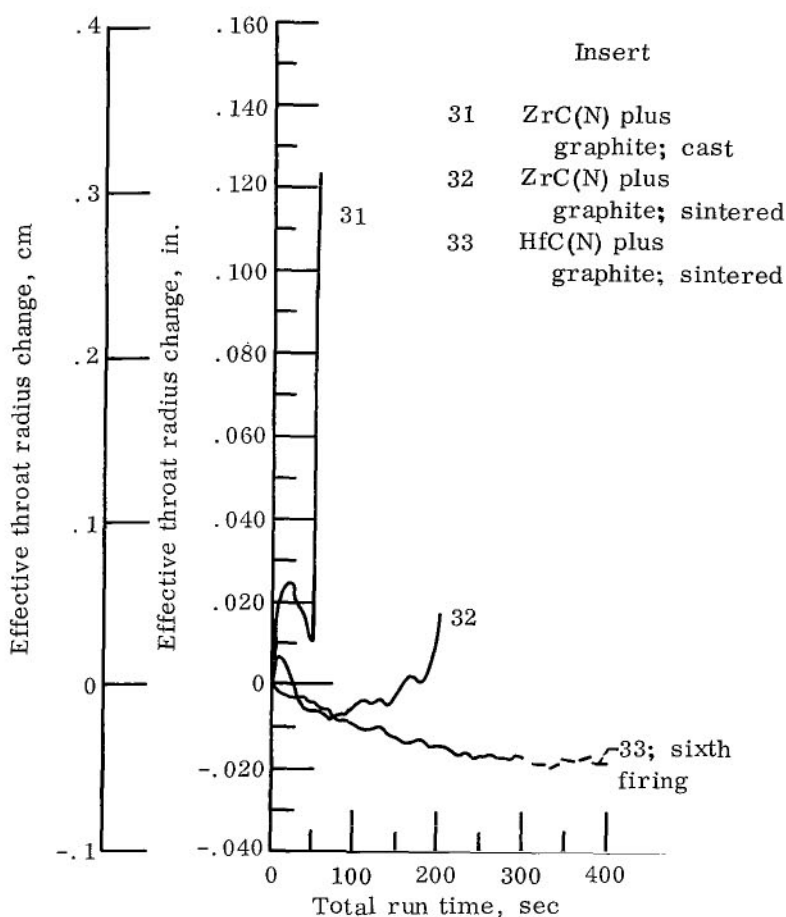
Figure 18. - Throat erosion of hypereutectic carbonitride inserts.

Insert 31 was prepared from a cast billet of $Zr(C, N)$ which contained less than 0.10 weight percent nitrogen (private communication from Battelle Memorial Institute). Insert 32 was made from a mixture of ZrC and zirconium nitride (ZrN) which resulted in a final nitrogen content of approximately 1.0 weight percent after pressing and sintering. Figure 18 is a plot of the firing data for both inserts. It was concluded that the case insert, regardless of the nitrogen content, was inferior in erosion resistance to the hot-pressed sample. The cast insert (31) disintegrated and was lost during the firing. Insert 32 ran for 200 seconds prior to erosion. Only nominal circumferential cracking was observed after shutdown (table VI(32)).

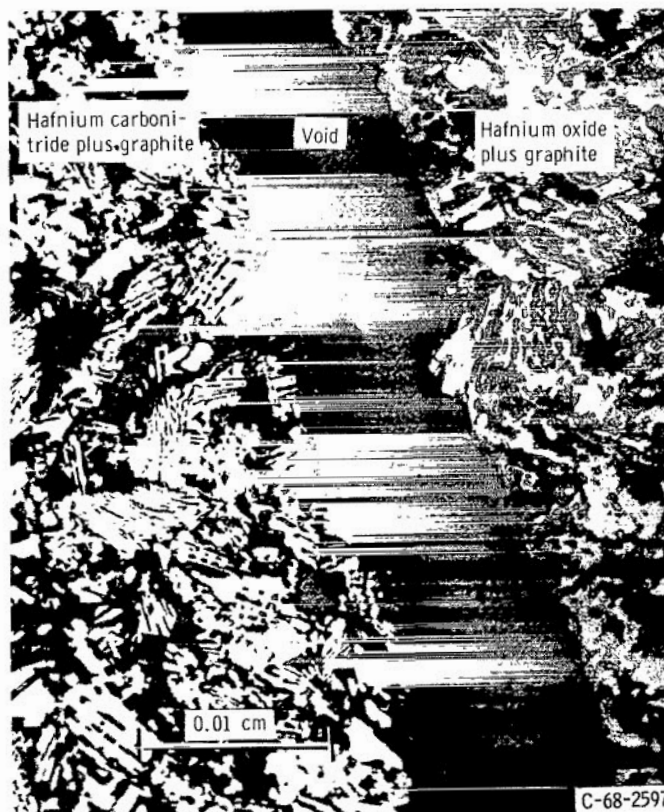
Figure 19. - Postfiring photomicrograph of hafnium carbonitride insert (33).

The surface layer contained many small fissures or checks which did not extend into or degrade the primary material structure. Surface checking is caused by thermal stresses in the relatively weak chemical reaction zone which is formed in place during rocket firings. Mechanical erosion could result from spallation of surface particles when the local shear forces exceed the shear strength in the reaction zone. The difference between the oxidized layer and the material underneath is shown in figure 19. The bond between the two materials was weak with an excess of carbon in the area. Further development should be concentrated on strengthening the oxide layer and eliminating the cause of

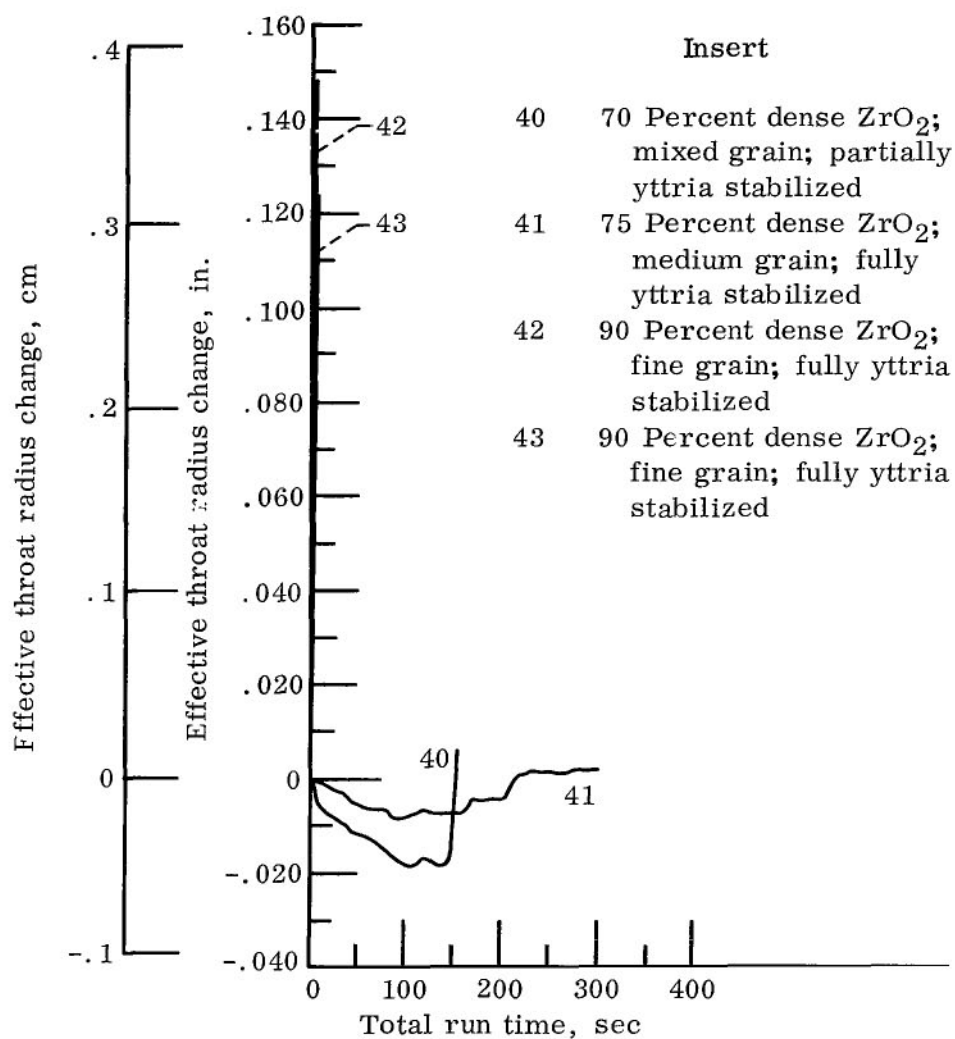
Figure 23. - Throat erosion for yttria stabilized zirconium oxide inserts.

Zirconium oxide-yttria stabilized. - Zirconium oxide is a very interesting material for use in the storable-propellant environment. Its melting temperature in excess of 4500°F (2750 K) and its high resistance to oxidation together with high strength make it very attractive. Unfortunately, unalloyed ZrO_2 is highly susceptible to thermal stress cracking. When unstabilized pure ZrO_2 is heated, the crystalline structure changes from monoclinic to tetragonal, which results in a volume decrease. To prevent cracking, which is associated with this volume change, from taking place, various stabilizing agents have been tried. Calcium oxide is one of the most commonly used stabilizers and has been effective for low heat-flux environments. It has not proved successful where the heat flux has been large, as is typical in a rocket engine. The Air Force has experimented with the use of rare earth oxides as stabilization agents for ZrO_2 (ref. 5). Recently, yttria (Y_2O_3) was shown to be quite promising. Four yttria-stabilized inserts were evaluated (inserts 40 to 43). Inserts 40 and 41 were compacted to approximately 75 percent theoretical density, and inserts 42 and 43 had a density of 90 percent. The low-density

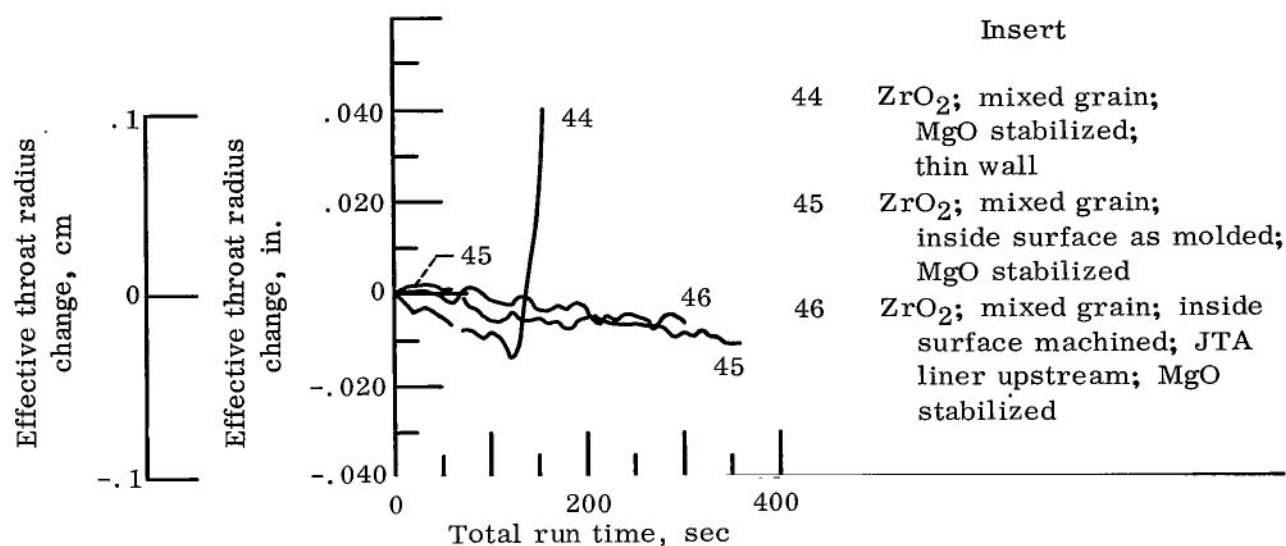
Figure 24. - Throat erosion for sintered, mixed-grains size zirconium oxide inserts.

Zirconium oxide, sintered, mixed grain size. - The firing data for three ZrO_2 inserts (44 to 46) are presented in figure 24. All three inserts were hot pressed from a mixed-grain-size, magnesia-stabilized mix. The outside of insert 44 was machined to have approximately one-half the wall thickness of the other two inserts in an attempt to minimize thermal stresses. A 0.250-inch (0.508-cm) thick RVC graphite sleeve was used as a backup material for insert 44. Slight axial and circumferential cracks were observed on the inside surface after the initial 60-second firing. The second firing of insert 44 resulted in loss of the insert throat section. Note the rapid increase in throat radius shown

in figure 24 and the post-test photograph in table VI(44). This is also the type of catastrophic failure observed when structural failures occur in larger throat sizes (ref. 2).

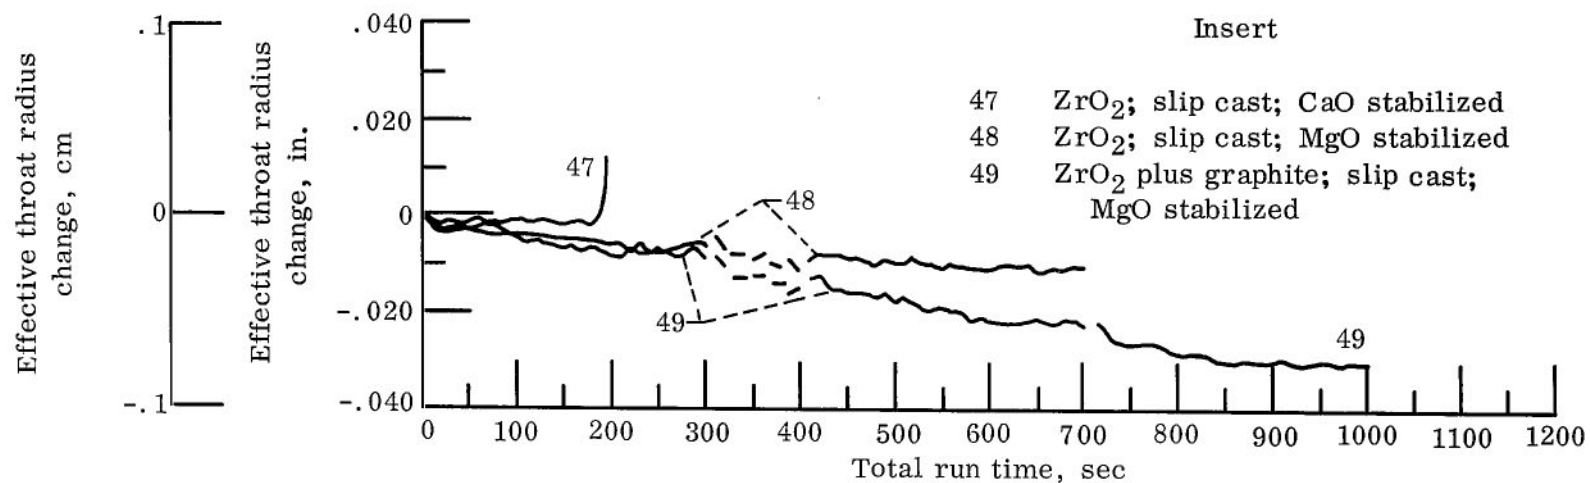
Figure 25. - Throat erosion for slip-cast, mixed-grain-size zirconium oxide inserts.

Zirconium oxide, slip cast mixed-grain size. - Insert 47 was prepared from slip-cast ZrO_2 stabilized with calcium oxide (CaO); the stabilization agent used for 48 and 49 was magnesium oxide. The importance of stabilizing ZrO_2 is due to the volume change

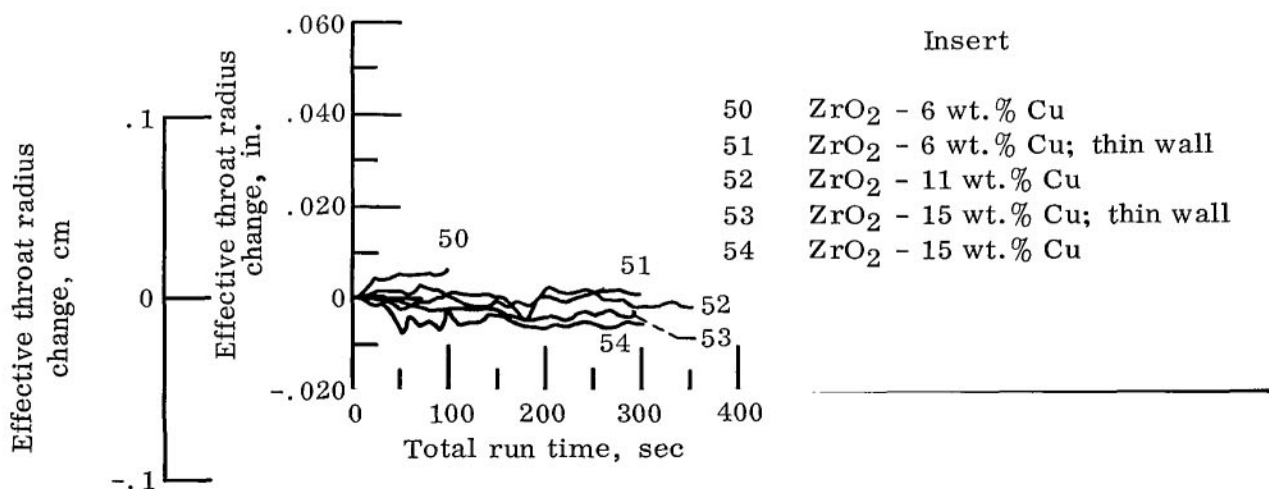
Figure 26. - Throat erosion for zirconium oxide - copper inserts.

Zirconium oxide-copper (anion deficient). - Five proprietary (unpublished data from S. Brown, Rocketdyne Div. of North American Aviation Corp.) anion deficient ZrO_2 inserts were test fired. Copper was added to the ZrO_2 matrix to increase the thermal shock resistance. The variables investigated were copper content and insert wall thickness. Firing data for inserts 50 to 54 are presented in figure 26.

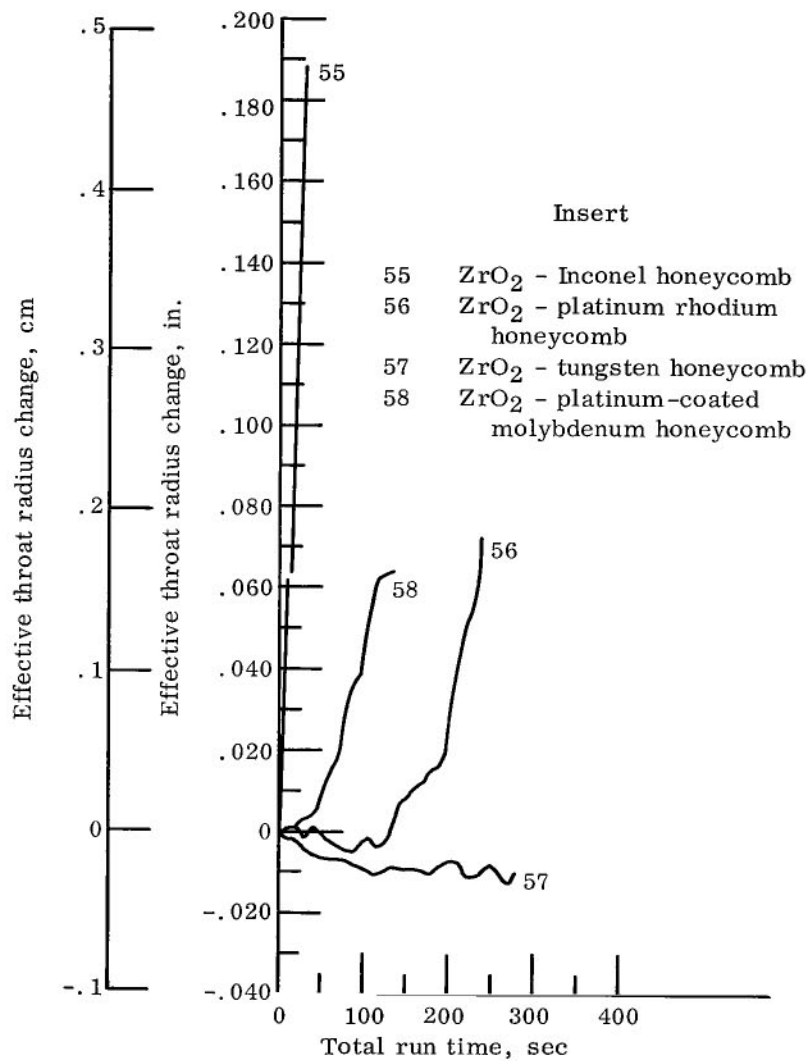
Figure 27. - Throat erosion for honeycomb reinforced zirconium oxide inserts.

Figure 27 presents the firing data for these four inserts. All failed structurally to some degree regardless of the reinforcing honeycomb employed. Surface spallation was extremely severe with the Inconel reinforcement (insert 55) (see film supplement). High erosion and severe cracking resulted in test termination for inserts 56 and 58. The best ZrO_2 -honeycomb insert tested was number 57, which was reinforced with tungsten. No throat erosion was measured but cracking and loss of material downstream of the throat precluded further testing (table VI(57)).

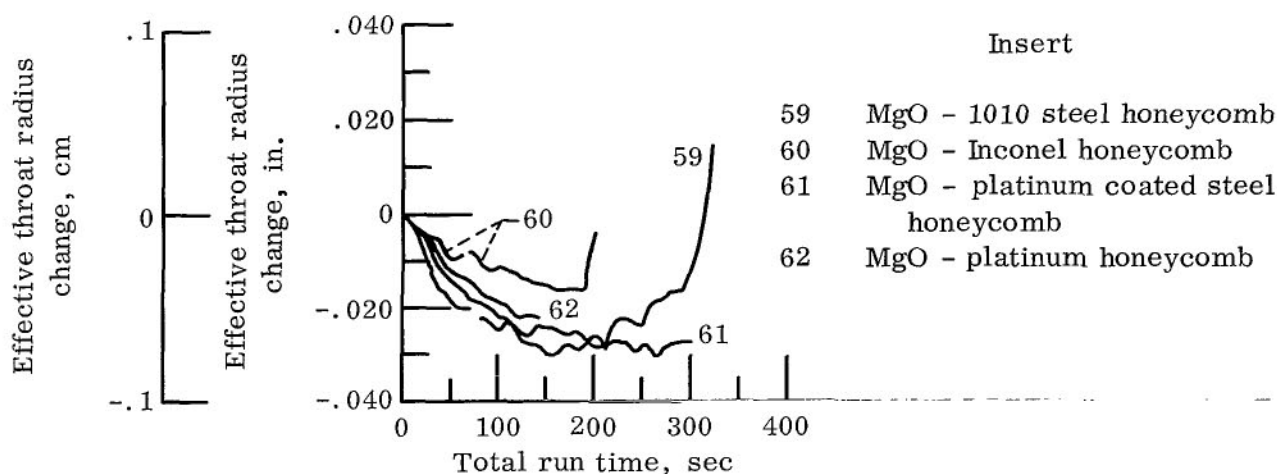
Figure 28. - Throat erosion for honeycomb reinforced magnesium oxide inserts.

Additional inserts of MgO reinforced with platinum coated steel honeycomb (61) and platinum honeycomb (62) were fabricated. The firing results are also shown in figure 28 and the post-test photographs are in table VI(61) and (62). Leading-edge failure and chemical reactivity was alleviated by using a JTA liner upstream of the throat insert. The platinum-coated steel honeycomb did not prevent structural failure of the ceramic matrix of insert 61 but throat erosion was prevented. The platinum honeycomb reinforced MgO (insert 62) showed no failure over the run time of 143 seconds. Unfortunately, fail-

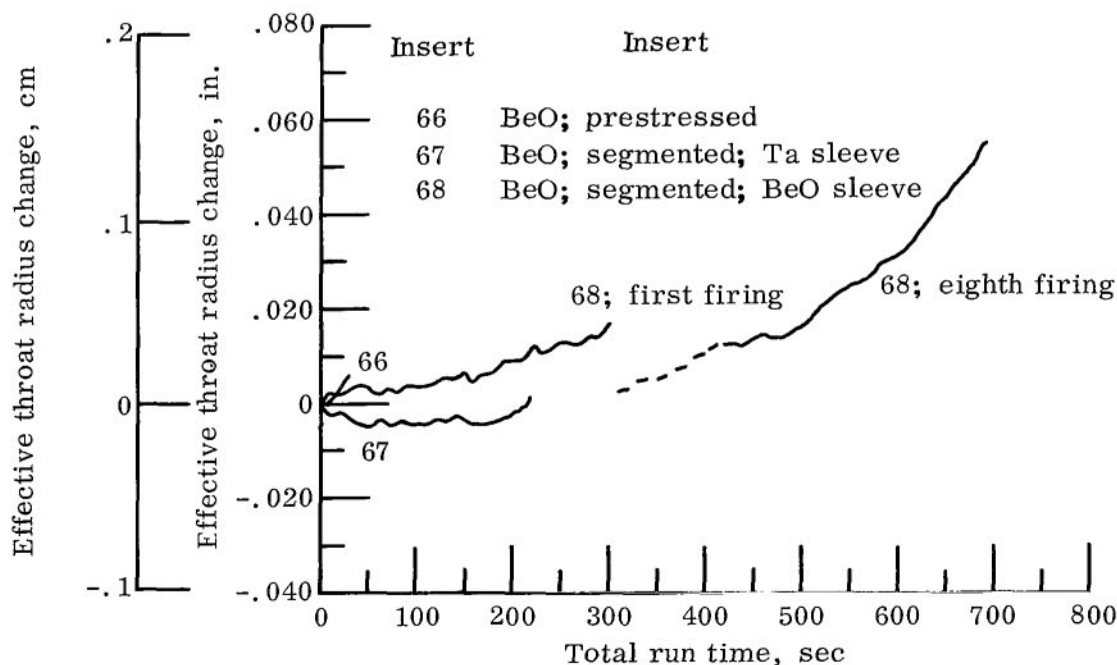
Figure 30. - Throat erosion for beryllium oxide inserts.

In order to prevent a tantalum-BeO reaction, another insert was designed with a 1/4-inch (0.635-cm) thick conical BeO sleeve on the outside to retain the segments. This insert (number 68) was tested for 691 seconds with structural cracking of the segments leading to the erosion shown on figure 30. Structural problems were first noticed after

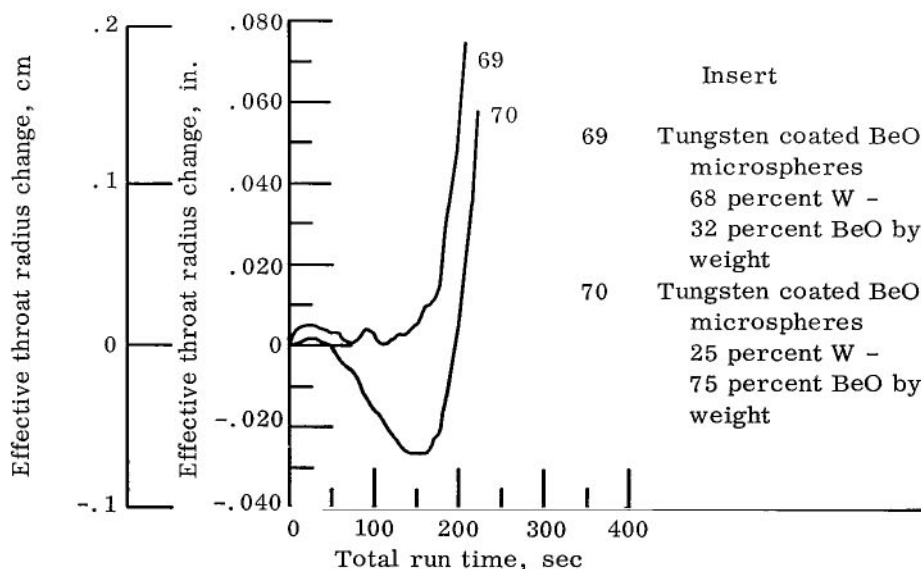
Figure 31. - Throat erosion for tungsten coated beryllium oxide microspheres.

The tungsten content for insert 70 was reduced to 25 weight percent. The throat erosion shown on figure 31 was not significantly improved over the erosion of insert 69. Pre- and post-test photomicrographs of insert 70 are shown in figure 32(b). The tungsten matrix is no longer continuous and a large number of voids are seen. The erosion failure of insert 70 was thought to be due to structural failure of the relatively porous BeO accentuated by oxidation of the tungsten.

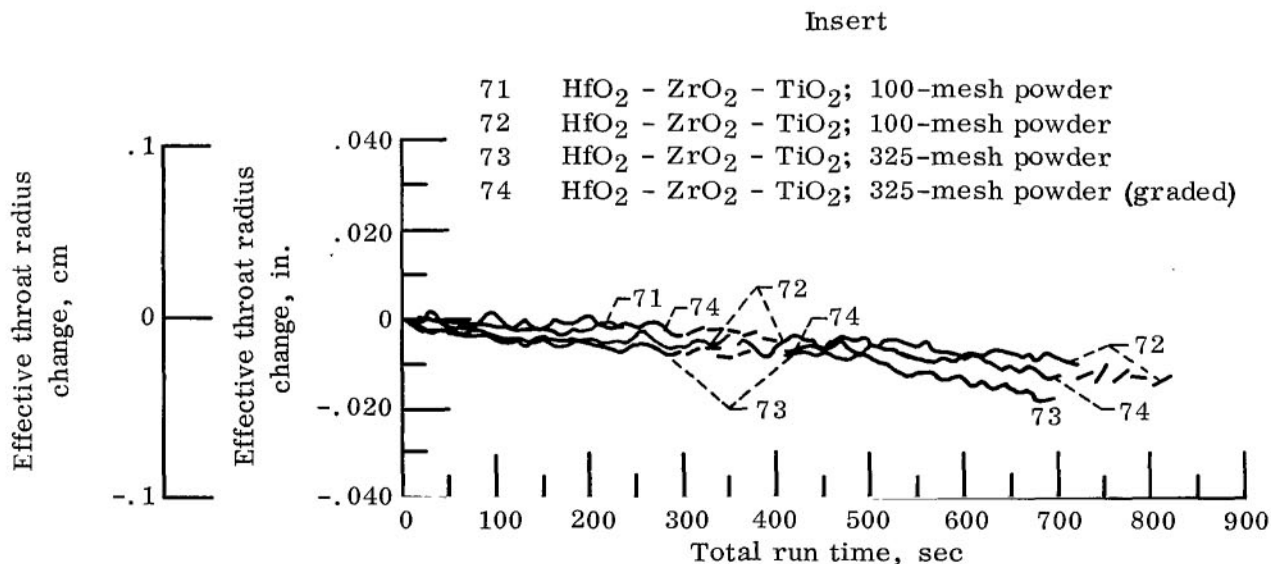
Figure 33. - Throat erosion for hafnium oxide - zirconium oxide - titanium oxide inserts.

Figure 33 presents the firing data for inserts 71 to 74. The inserts were prepared by mixing HfO_2 , ZrO_2 , and TiO_2 . The mixture was pressed, reaction sintered and pulverized, then isostatically pressed and resintered. Because of a firing malfunction during the scheduled 300-second run of insert 71, the run was terminated after only 229 seconds. It was decided to section the insert at this time in order to make a decision as to what composition would be best for insert 72. No cracks, melting or erosion were observed, and insert 72 was made identical to insert 71. To assess the long-term capabilities, an initial run of 358 seconds was made. Again, no cracking, melting or erosion was observed and a second firing was made for 365 seconds. After a total firing time of 723 seconds, a few minor surface fissures were noted. Three 20-second runs were then made, but the insert was not inspected between runs. After the fourth and fifth 20-second runs, the insert was inspected in the test cell. The six axial cracks which appeared after the fourth 20-second run were more severe and accompanied by some circumferential

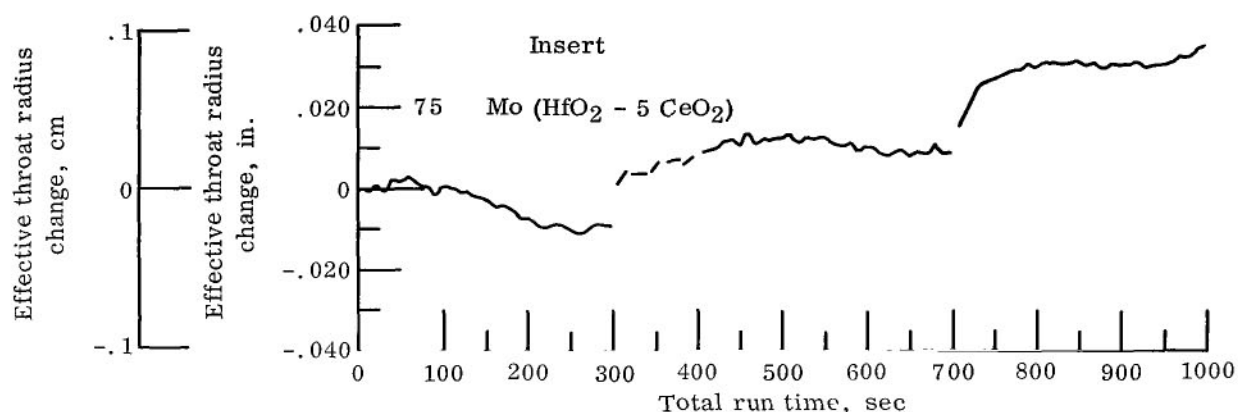
Figure 34. - Throat erosion for macrolaminate insert.

Nozzle 75 was composed of a macrolaminate structure of molybdenum and HfO_2 with cesium oxide (CeO) added as a bonding agent. The composite consisted of discrete layers of HfO_2 and molybdenum within each macroparticle. The firing results are shown on figure 34. This insert was the only one tested that survived the 700-second duty cycle with neither cracking nor appreciable erosion. A final 300-second firing produced the erosion

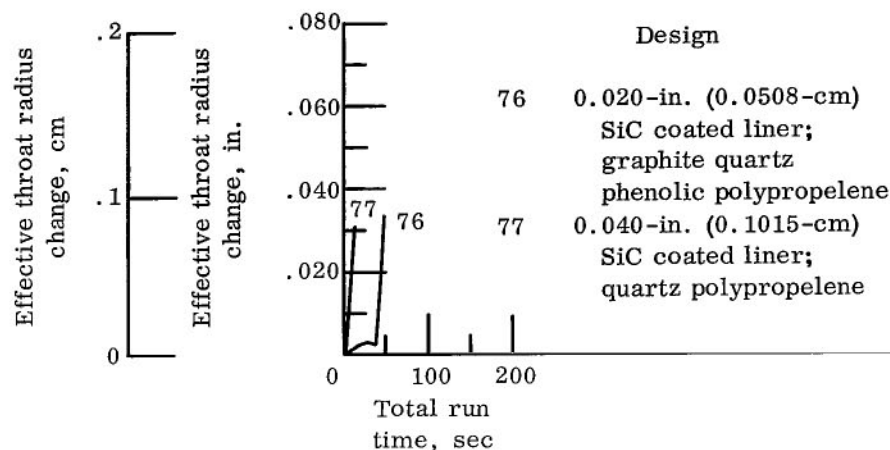
Figure 36. - Throat erosion for pyroconvective nozzle designs.

The design concept consisted of a refractory SiC coated graphite liner, grooved on the outside diameter, and backed with a gas reservoir structure. The reservoir system of nozzle design 76 was a composite of quartz and graphite fibers impregnated with a polypropylene-phenolic binder. The binder volatilized on heating and provided cooling gas which escaped through holes in the liner, located downstream of the throat plane. The reservoir system for nozzle 77 did not contain graphite fibers and was different in other respects including the elimination of the downstream holes. A comparison of configurations D and E (fig. 5(d) and (e)) illustrates the design differences between 76 and 77. Figure 36 presents the firing data for the two nozzles. Both nozzles failed by cracking of the composite liner probably within the first few seconds of firing time. Residual stresses

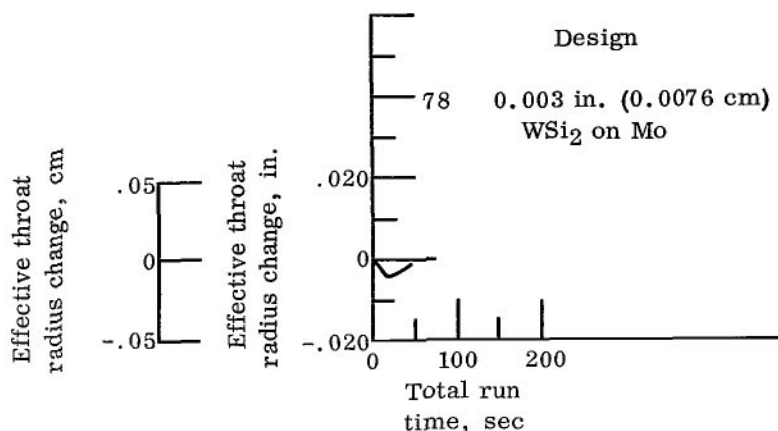
Figure 37. - Throat erosion for tungsten disilicide coated molybdenum nozzle design.

The nozzle test was terminated after 45 seconds because of a combustion gas leak. The throat erosion data are on figure 37. Inspection of the nozzle revealed partial removal of the coating by a combination of melting and oxidation. The extent of coating loss and oxidation of the molybdenum substrate may be seen in table VI(78). The failure indi-

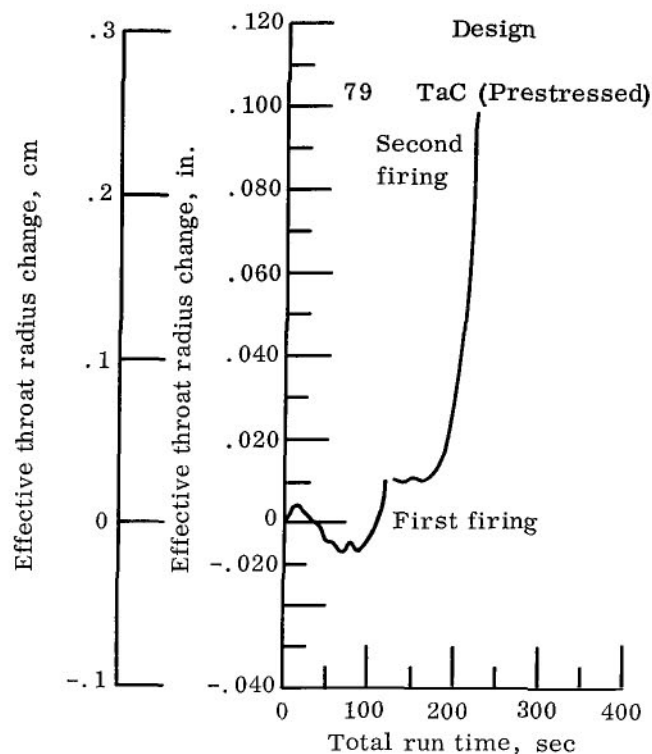
Figure 38. - Throat erosion for prestressed tantalum carbide nozzle design.

The test firing produced throat erosion as shown in figure 38. The erosion as shown in the film supplement was due primarily to oxidation. A second firing was made to measure the oxidation rate and the effect of restart on the prestressed design. The insert was not cracked following the initial firing. After the second firing, however, axial cracks were found in the insert (see table VI(79)). The cracking illustrates the difficulty of maintaining elastic behavior of material combinations whose properties are not precisely known. The nozzle design attempted to control the oxidation of the tantalum carbide insert by keeping the surface temperature below 3700° F (2310 K) for a 300-second

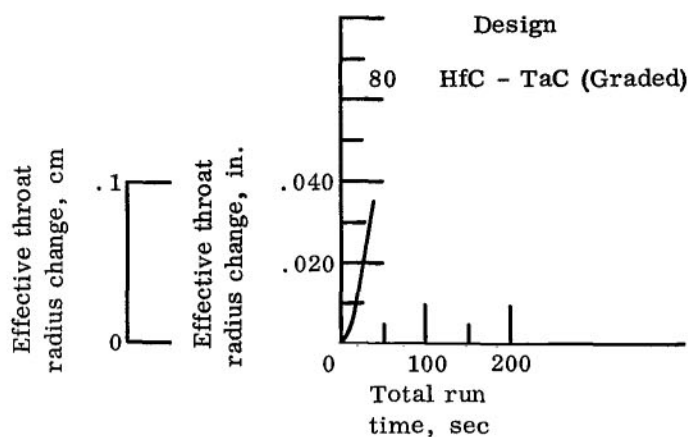
Figure 39. - Throat erosion for hafnium carbide - graded tantalum carbide nozzle design.

Figure 5(h) details the graded carbide design concept used for nozzle 80. The design consisted of four carbide layers with varying graphite content. The firing data, presented in figure 39, indicates a rapid erosion failure. Post-test inspection of the insert (table VI(80)) showed two circumferential cracks completely through the insert as well as numerous axial cracks. Although some pieces were lost from the insert during firing, the major contribution to throat erosion was oxidation of the HfC on the inside surface. The thickness of the HfC remaining at the throat was about 0.070 inch (0.178 cm). Adding the 0.035-inch (0.089-cm) erosion gives a layer 0.105-inch (0.267-cm) thick at the throat compared with the 0.100-inch (0.254-cm) design value. The other layers, however,

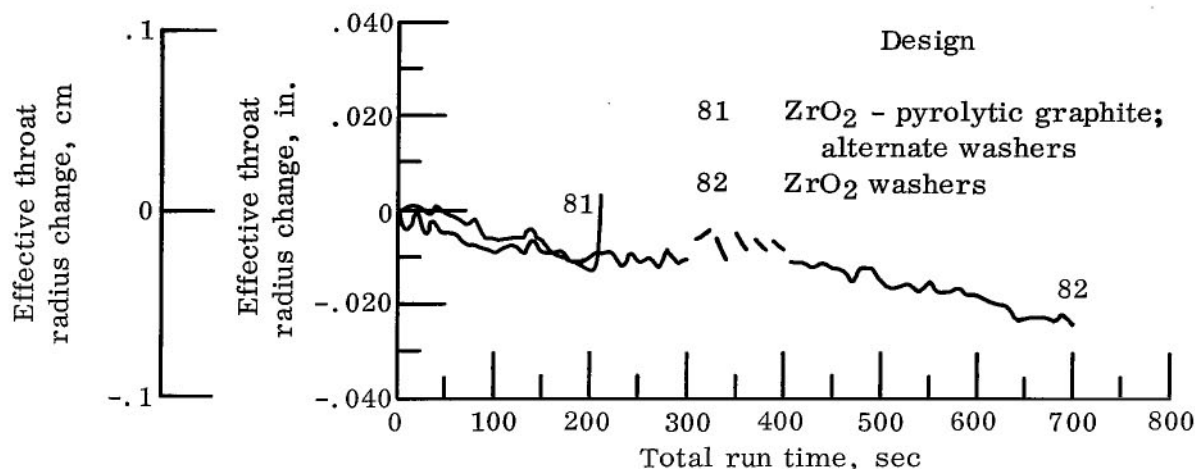
Figure 40. - Throat erosion for pyrolytic graphite laminated zirconium oxide washers.

Nozzle design 81 was composed of alternate axial washers of ZrO_2 and pyrolytic

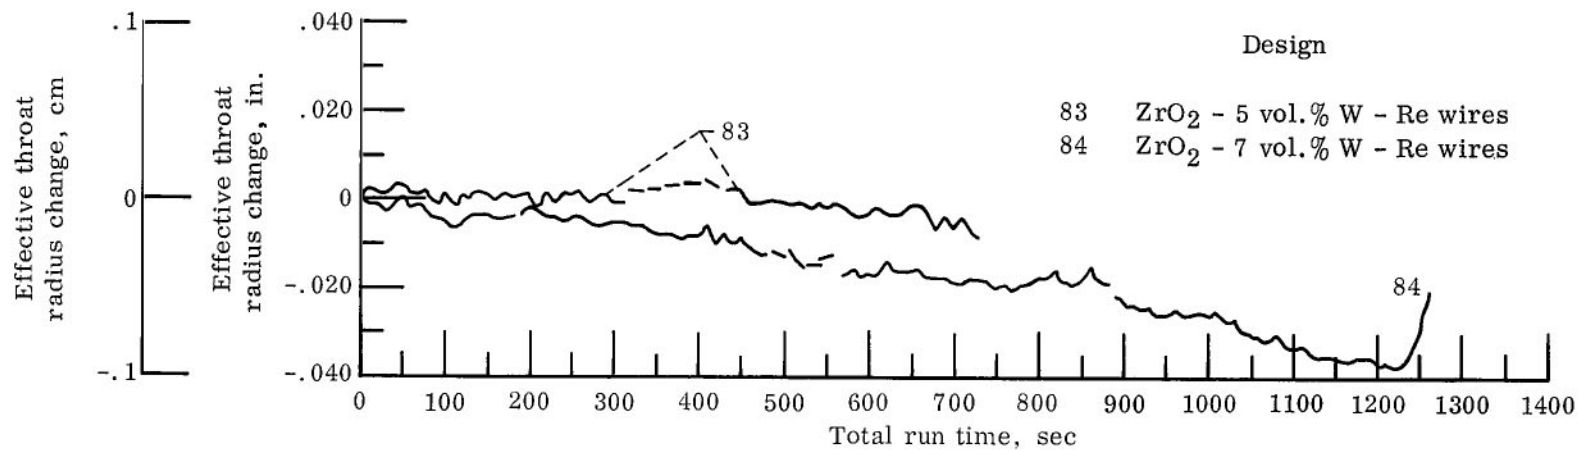
Figure 41. - Throat erosion for tungsten-rhenium wire reinforced zirconium oxide.

Figure 5(j) is a sketch of the design used for nozzles 83 and 84. Nozzle 83 contained 5-volume-percent and nozzle 84 contained 7-volume-percent tungsten - 3-weight-percent rhenium wires dispersed in a ZrO_2 matrix. Wire diameter was 0.0035 inch (0.0089 cm) and wire length was nominally 3/16 inch (0.476 cm). Figure 41 presents the firing data. Both inserts survived the required duty cycle with no erosion and only minor surface spallation. However, both were cracked after the first 300-second cycle.

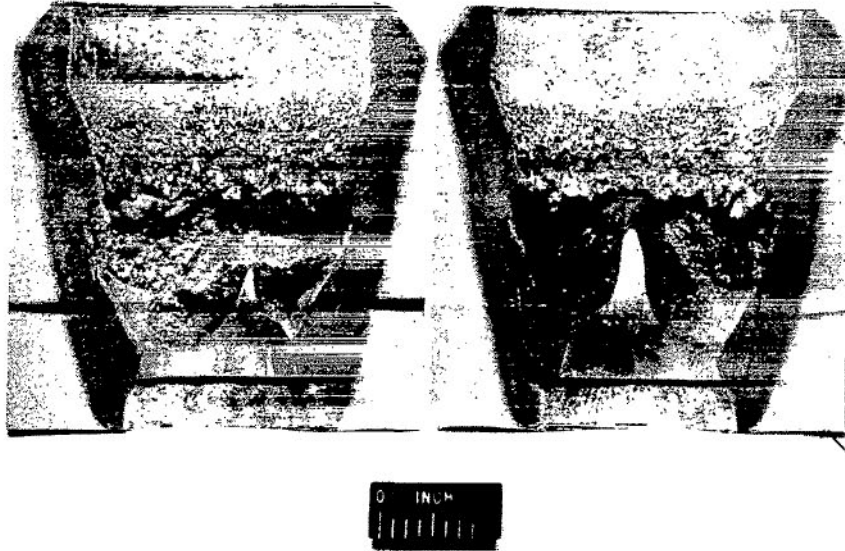
(7) Insert 7; injector 1A

Material		Form	Manufacturer	Configuration (a)	Additional layers
Coating	0.060-in. (0.1522-cm) pyrolytic graphite	a-b plane axial	American Metal Products	A	None
Insert	Pyrolyzed graphite cloth-phenolic	90° centerline			
Envelope	Silica phenolic (MX 2641)	90° centerline	Fiberite	4-in. (10.15-cm) o.d.	None

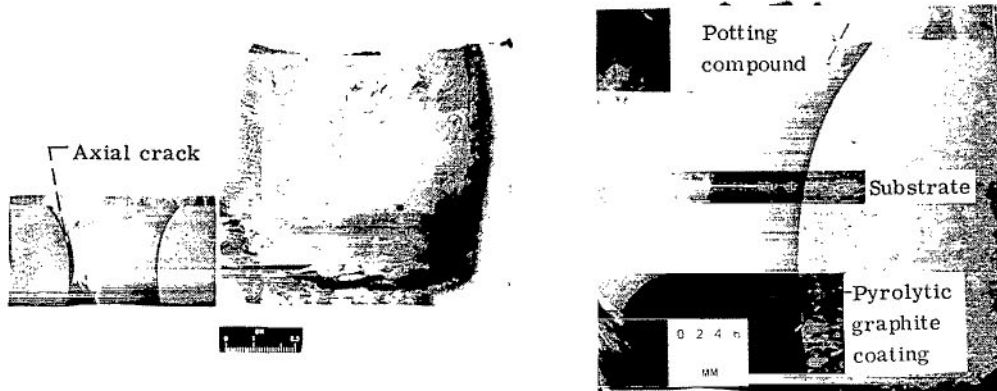
(10) Insert 10; injector 2

Material		Form	Manufacturer	Configuration (a)	Additional layers
Coating	0.040-in. (0.1015-cm) pyrolytic graphite	a-b plane axial	Atlantic Research	B (modified, 1.81-in. (4.60-cm) diam at insert leading edge)	JTA graphite upstream of throat
Insert	Low-modulus pyrolyzed graphite cloth substrate	-----			
Envelope	Silica phenolic (MX 2641)	Molded squares	-----	5-in. (12.7-cm) o.d.	None

The erosion rate for insert 10 was approximately 0.0005 inch per second (0.00127 cm/sec), and the firing was proceeding smoothly until the substrate cracked after about 50 seconds. Table VI(10) shows the cracked substrate and ablative holder. The coating was still well bonded to the substrate, however. The film supplement illustrates the coating loss, starting at the leading edge and progressing through the throat plane, primarily due to oxidation.

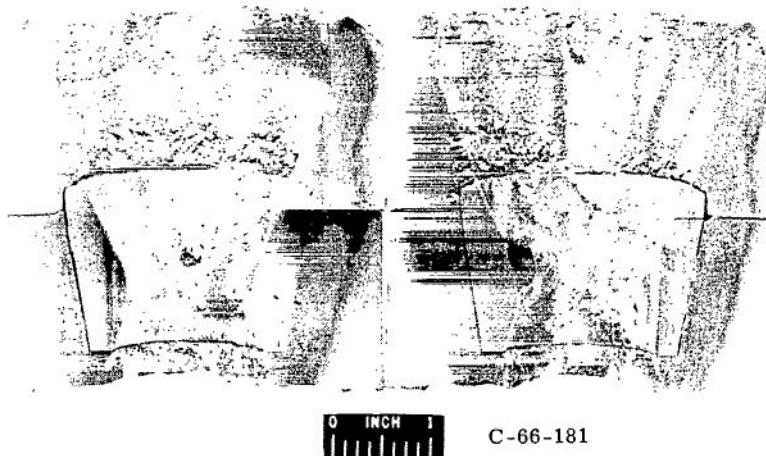
(14) Insert 14; injector 2

Material			Form		Manufacturer	Configuration (a)	Additional layers
Coating	0.030-in. (0.0762-cm) SiC		Pyrolytic		Dow Corning	A	None
Insert	UT-6		-----			Fiberite	4.0-in. (10.15-cm) o.d.
Envelope	Silica phenolic (MX 2641)		90° centerline				
Run	Chamber pressure, P _c		Run time, sec	Total change in effective throat radius, ΔR		Remarks	
	psia	kN/m ²		in.	cm		
283	94.2	648	93.8	0.005	0.0127	Coating oxidized, substrate erosion beginning; shutdown at first sign of coating failure

Insert 14, an 0.030-inch (0.0762-cm) thick pyrolytically deposited coating of SiC on an isotropic substrate (Ultra Carbon UT-6) failed by oxidation after approximately 90 seconds. The oxidation was accelerated by the flow of silica from the upstream silica phenolic liner. In those areas where coating remained, the bond was adherent.

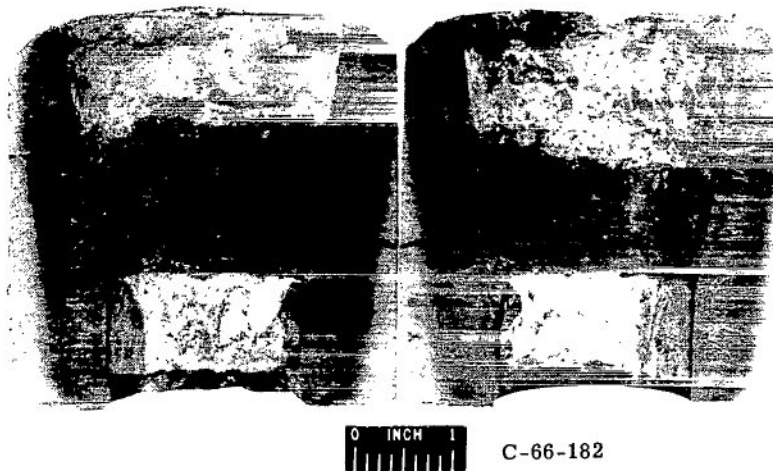
(29) Insert 29; injector 2

Material		Form		Manufacturer		Configuration (a)	Additional layers
Insert		ZrC plus graphite		Hypereutectic cast		Aerospace Corporation		C	JTA liner upstream of throat insert
Envelope		Silica phenolic (MX 2641)		90° centerline		Fiberite		4-in. (10.15-cm) o.d.	None
Run	Chamber pressure, P_c		Oxidant-fuel ratio, O/F	Run time, sec	Total change in effective throat radius, ΔR		Remarks		
	psia	kN/m ²			in.	cm			
314	101.8	701	2.03	24.9	-0.025	-0.066	Seal leak at chamber		
326	104.8	721	2.00	<u>153.1</u> 178.0	-.011	-.029	Gas flow behind insert, oxidation

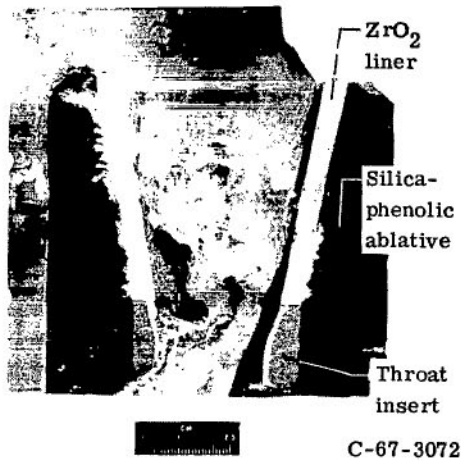
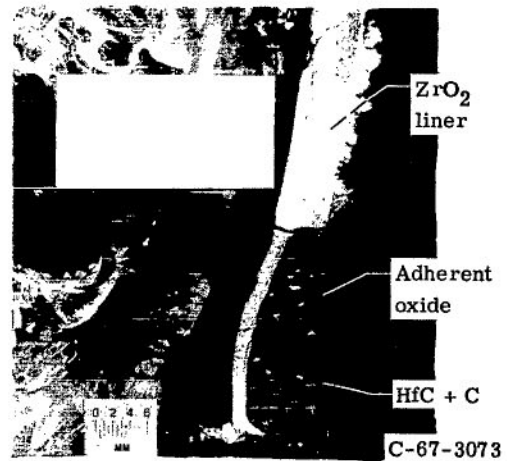
(30) Insert 30; injector 2

Material		Form	Manufacturer	Configuration (a)	Additional layers
Insert	HfC plus graphite		Hypereutectic cast	Aerospace Corporation	C	ZrO ₂ liner upstream of throat insert
Envelope	Silica phenolic (MX 2641)		Molded squares	Fiberite	4-in. (10.15-cm) o.d.	None

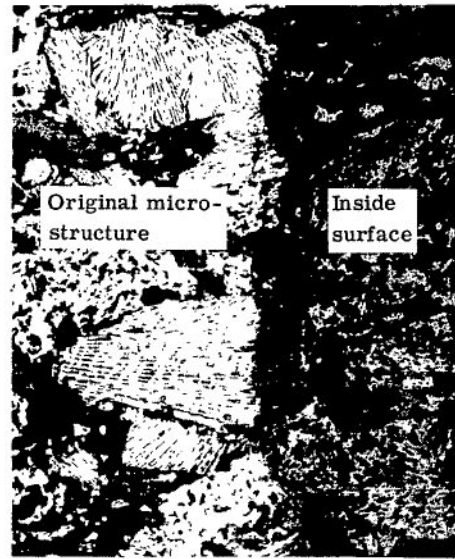
Material	Form	Manufacturer	Configuration (a)	Additional layers
Insert			ZrC(N) plus graphite	Sintered	Battelle Memorial Institute	B	JTA liner upstream of throat insert
Envelope			Silica phenolic (MX 2641)	90° centerline	Fiberite	4-in. (10.15-cm) o.d.	None
Run	Chamber pressure, P_c		Oxidant-fuel ratio, O/F	Run time, sec	Total change in effective throat radius, ΔR		Remarks
	psia	kN/m ²			in.	cm	
355	100.8	693	2.13	204.5	0.011	0.0254	Erosion and oxidation; circumferential cracks; shutdown at first sign of erosion
